Manhole Inspection Summary

Manhole # S23W__032MH

Insp Date: **2/10/09 1:39 PM**

Location Address: **2118 Ontario Ave.**

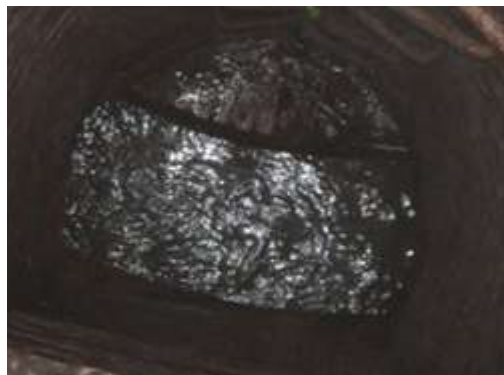
Defect 1

Count: **14** Missing: **0** ☒ **Corroded**

corroded steps

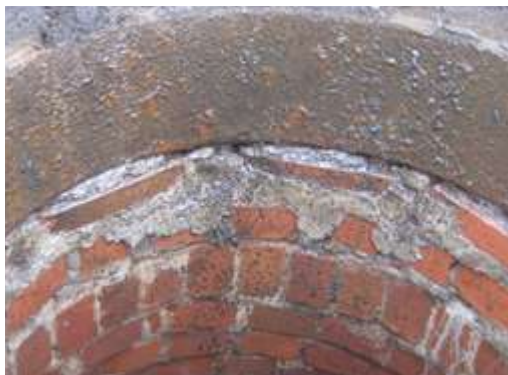
Defect 3

☒ **Leaks**

Condition: ☐ Sound ☐ Cracked ☐ Root Intrusion ☐ Loose Brick ☒ **Deteriorated**

Infiltration: ☐ None ☐ Joint ☐ Cracks ☒ **Mortar** ☐ Roots ☐ Wall

frame inflow at cover, chimney deteriorated, chmney infiltration at mortar

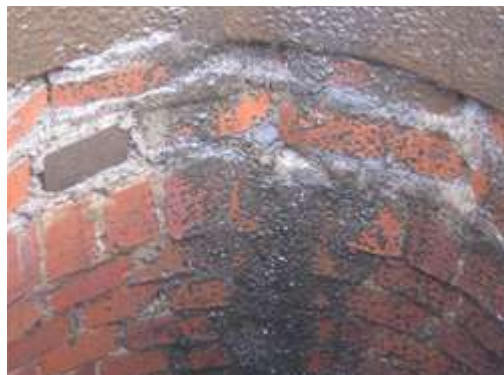
Defect 2

Infiltration: ☐ None ☒ **Joint** ☐ Cracks ☒ **Mortar** ☐ Roots ☒ **Wall**

corbel infiltration at chimney joint, mortar, and wall
